**Title:**           **Fragility Models that Reflect Pipe Damage in the Napa 2014 M 6.0 Earthquake**

# **Fragility Models that Reflect Pipe Damage in the Seismic 2014 Napa M 6.0 Earthquake**

John M. Eidinger\*

## **ABSTRACT**

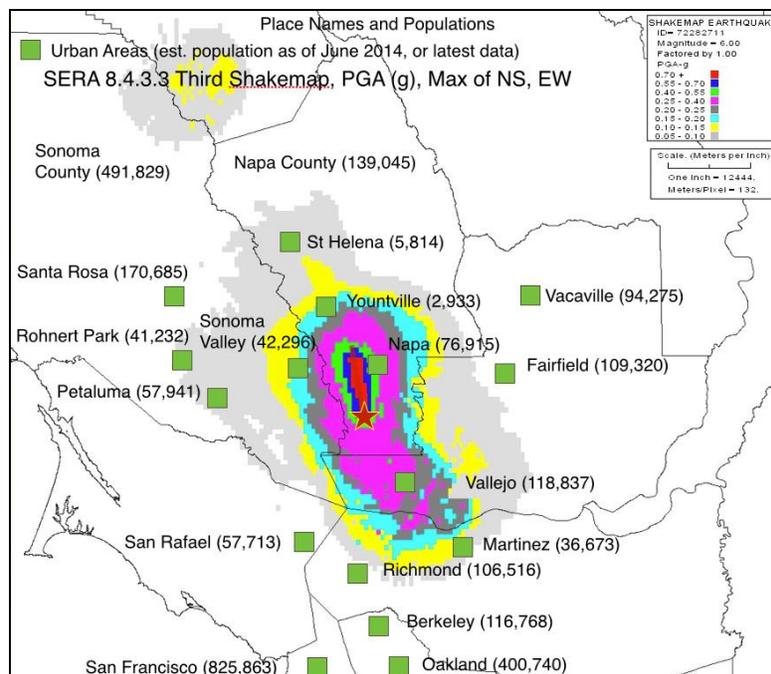
Figure 2. Ground shaking levels (PGA) on the Napa 2014 M 6.0 earthquake

Figure 2 shows the level of ground shaking in the earthquake (in PGA, g), along with names of major cities and towns, and latest census populations shown in (brackets). The star shows the epicenter, with the rupture going northwards. Red areas show  $PGA > 0.7g$ . White areas show  $PGA < 0.05g$ . Black lines show boundaries of counties.

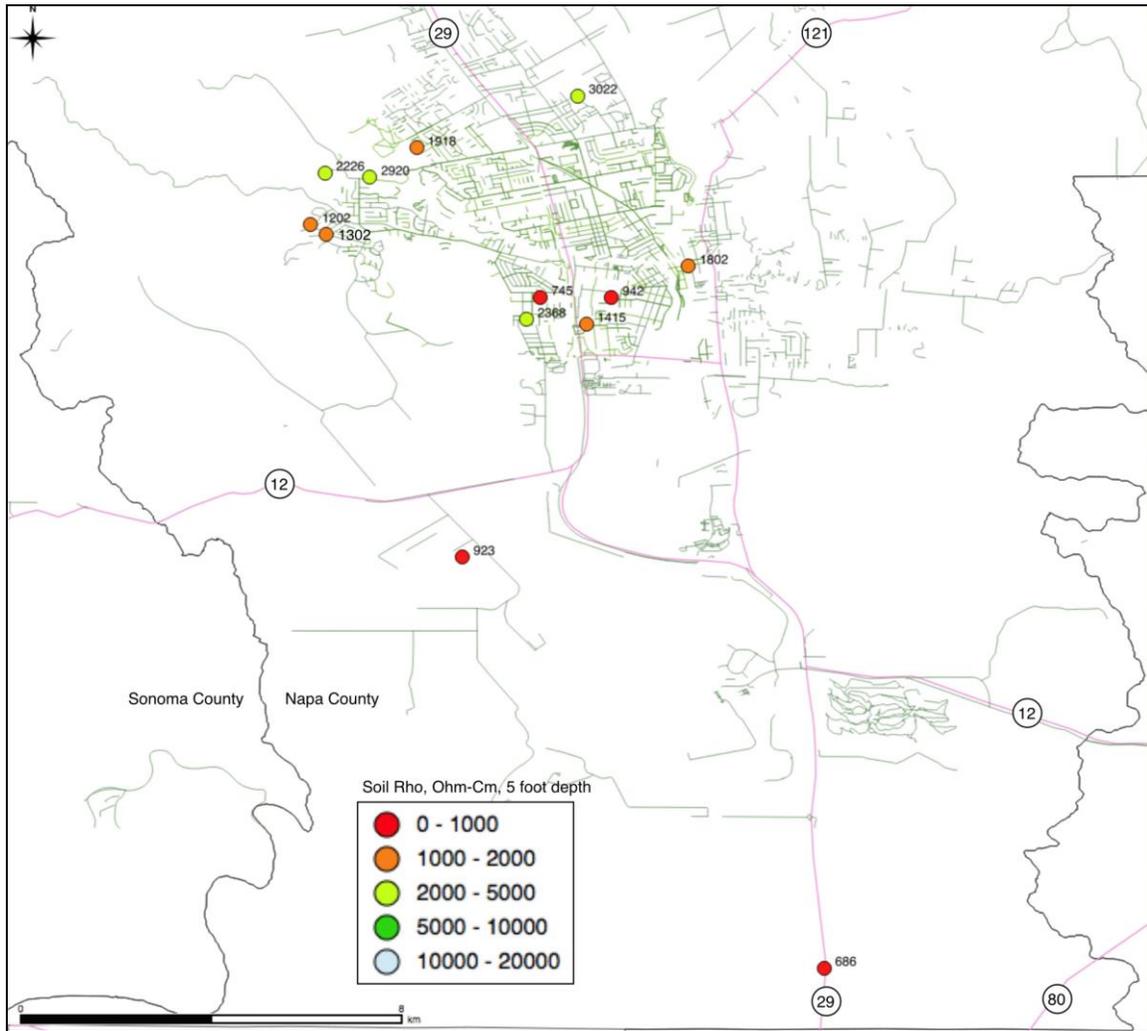
*Figure 3. Soil Resistivity and Location of Pipe Repairs for Napa Water Pipe*

Figure 3 shows the results from soil resistivity ( $\rho$ ) tests performed in Napa after the earthquake. The locations of the  $\rho$  tests are indicated by small colored dots, and the actual test value at the

depth of the water pipes (1.5 meters below grade is most common) is shown next to the symbol. The numbers in round circles are the highway numbers of major roads in and near Napa.

Figure 3 shows that the soils in Napa are extremely aggressive. This may be in part due to the volcanic origins of the soils; many are clayey-in nature. At three test locations, Rho was under 1,000 ohm-cm (extremely corrosive); four more tests showed Rho from 1,000 to 2,000 ohm-cm (very aggressive); and four more tests showed Rho from 2,000 to 3,022 ohm-cm.

The Napa water department reports that their ductile iron pipe has had a fairly high leak rate, even without the earthquake, and this reflects that Napa apparently did not install polyethylene "baggies" over the ductile iron pipe. The very aggressive nature of the soils; coupled with the relatively thinner wall thickness of ductile iron pipe, under 0.5 cm (0.2 inches), relative older but thicker cast iron pipe that are commonly 1.27 cm (0.5 inches) or thicker.

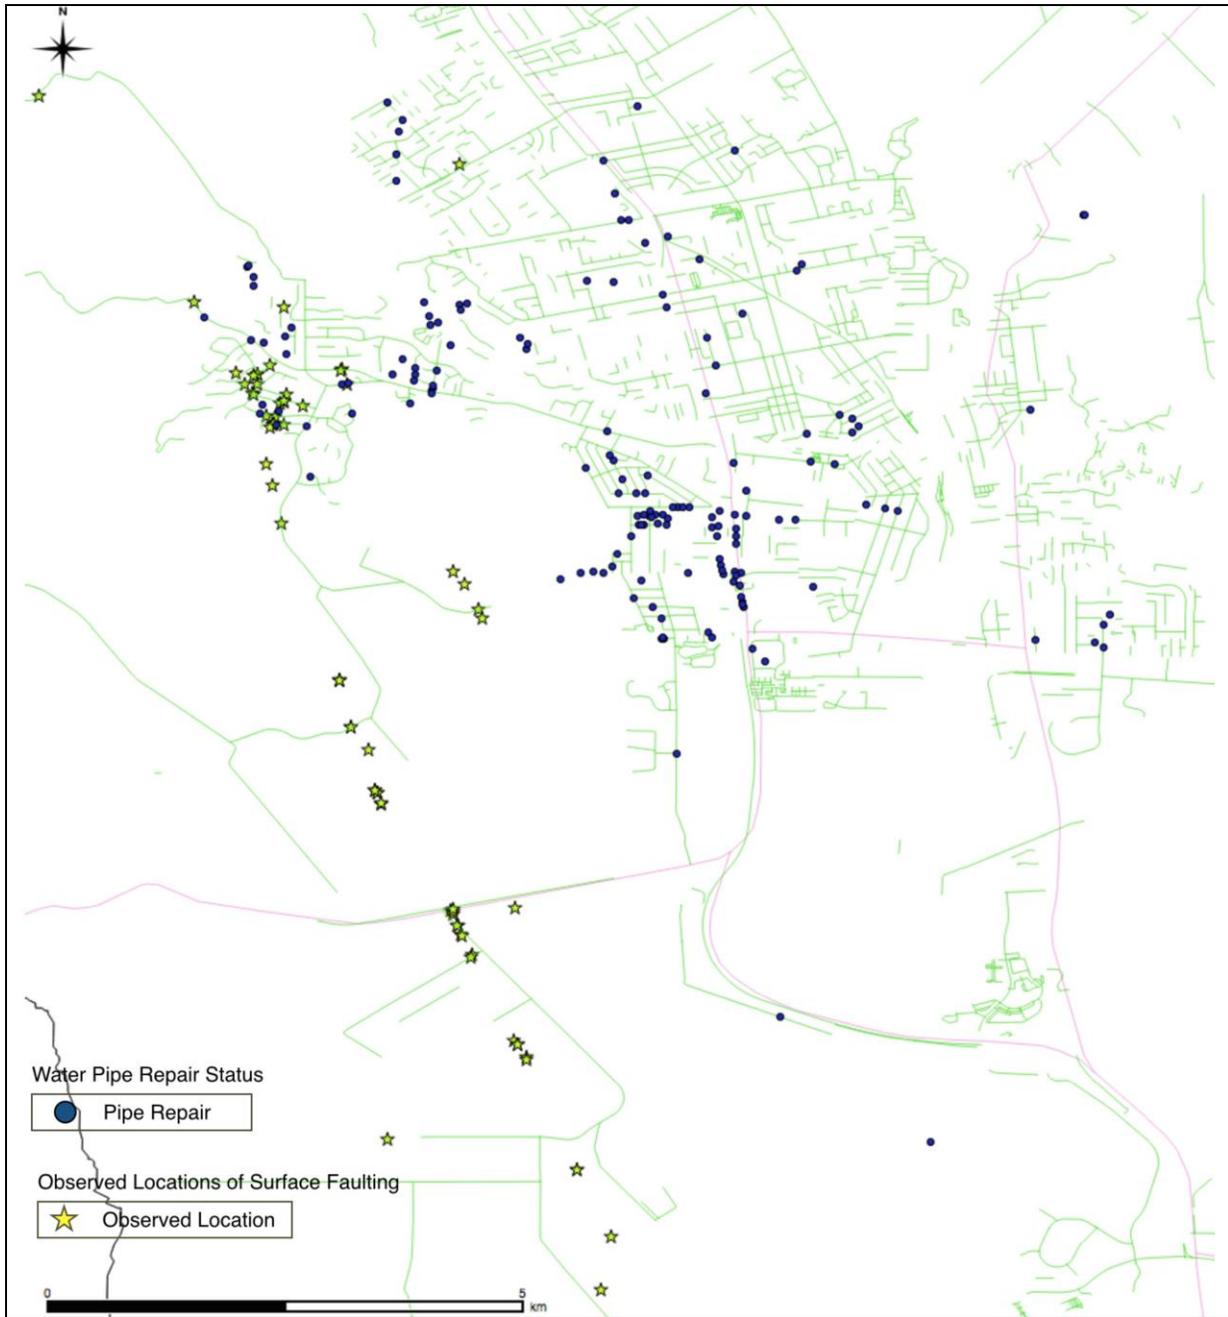
*Figure 4. Location of Surface Faulting and Water Pipe Repairs*

In the northwest part of the water system, there was surface faulting. Figure 4 (left) shows a map of the 71 locations with observed surface faulting (yellow stars), along with the pipe repair locations. The light green lines indicate streets; light blue lines indicate major roads / highways.

We reviewed the number of pipes that were located within about 152 meters (500 feet) from locations of surface faulting; and attributed that damage to surface faulting and not ground shaking or liquefaction effects. We also differentiated the number of pipes that were damaged due to liquefaction. Table 4 shows the results. The total number of pipes damaged from shaking was 122, with 23 repairs due to liquefaction, and 18 due to fault offset.

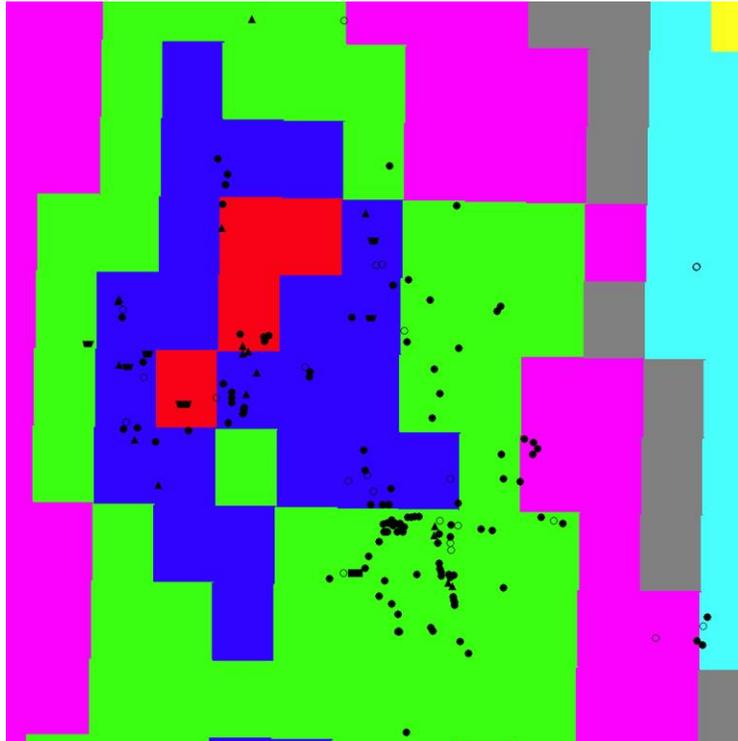
*Figure 5. ShakeMap PGVs (Maximum of NS, EW)*

Figure 5 shows the Peak Ground Velocity (PGV) map for the Napa area due to the August 2014 earthquake. This map shows the maximum of north-south or east-west direction PGV. Each "box"

represents an area of about 0.8 km (east-west) by 1 km (north-south). The symbols are at the locations of the pipe repairs as shown in Figure 4: solid dot: CI; triangle: DI; open dot = unknown; polygon: AC; square: PVC. The colors of the PGV shaking in Figure 5 correspond to: Red: PGV  $\geq$  85 cm/sec. Blue: PGV = 70 cm/sec to 85 cm/sec. Green: PGV = 55 cm/sec to 70 cm/sec. Magenta: PGV = 40 cm/sec to 55 cm/sec. Dark Grey: PGV = 30 cm/sec to 40 cm/sec. Cyan: PGV = 20 cm/sec to 30 cm/sec. Yellow: PGV = 10 cm/sec to 20 cm/sec

Using the corresponding PGV ShakeMap levels of shaking from Figure 5, Table 3 shows the number of pipe repairs that were subjected to various levels of PGV (totals add to 164; 163 elsewhere in this report; the 1 pipe repair location had uncertain attribute as to whether there was 1 or 2 repairs at that location).

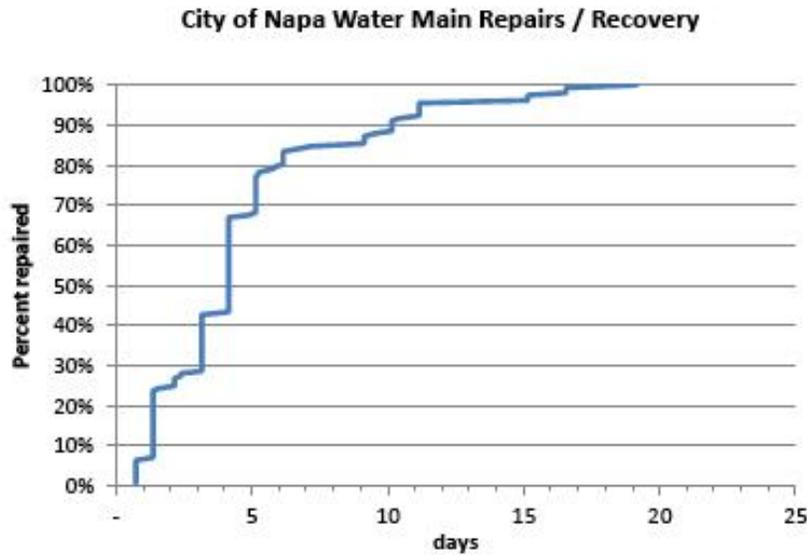
*Figure 6. Napa Water Recovery*

Figure 6 shows the restoration of water service after the earthquake.

All crews arrived with spare parts, trucks and equipment, typically 5 people per crew. All mutual aid crews were released by August 29 2014 (note the slow down in the rate of pipe repairs after Day 5, Figure 6). It was initially thought that the mutual aid crews were sufficient to effect nearly all the pipe repairs by August 29; however, over time, as the last pipe repairs were made, additional pipe leaks were identified as repaired pipes were re-pressurized.
