# The Damage Analysis of Distribution Pipes in Artificial Ground

Shu Kikuchi<sup>1)</sup>, Keita Obonai<sup>2)</sup>,  
Shinji Ogata<sup>3)</sup>, Nobuhiko Inoue<sup>4)</sup>, Tomoo Miyano<sup>5)</sup>

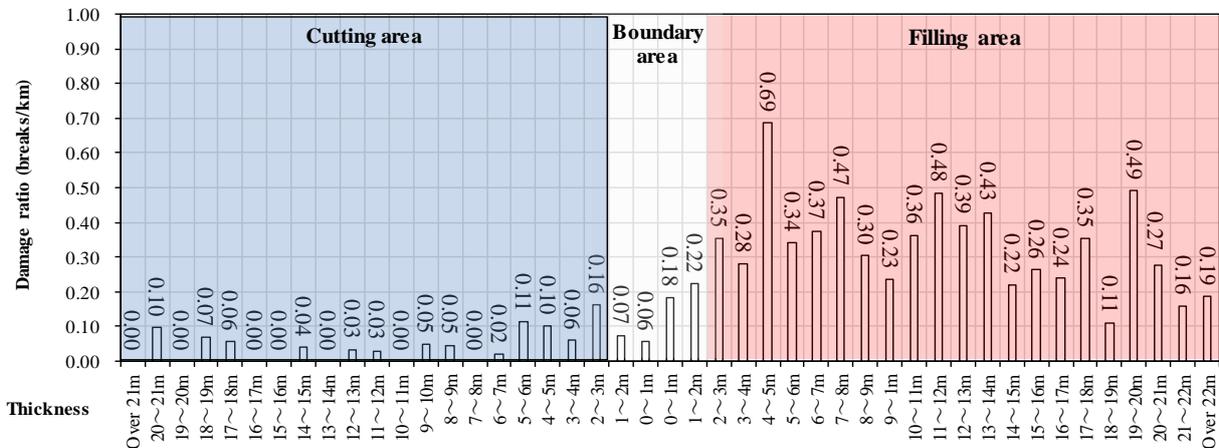
Figure 4 Damage ratio by the thickness of cutting and filling

Table 5 and Figure 4 show the damage ratio for distribution pipes in cutting, boundary and filling area. The damage ratio is 0.05 in cutting area, 0.13 in boundary area, and 0.36 in filling area respectively. When an earthquake happens, it is presumed that distribution pipelines are influenced by ground damage and broken mainly between cutting and filling area in artificial ground. It is so called the boundary area. However, this study shows a tendency that high damage ratio is cutting, boundary, and filling area in that order. Damage ratio in boundary area and filling area are 2.6 times and 7 times higher than that of in cutting area. Also it shows that the damage ratio in filling area is wholly high, and the highest damage ratio of the filling area is the thickness from 4 to 5 meter. This result shows that the damage to water pipelines varies to subsurface ground conditions even if the same shake happened in developed land. This result implies that filling area is affected with a shake relatively and pipelines installed in filling area were easy to break.

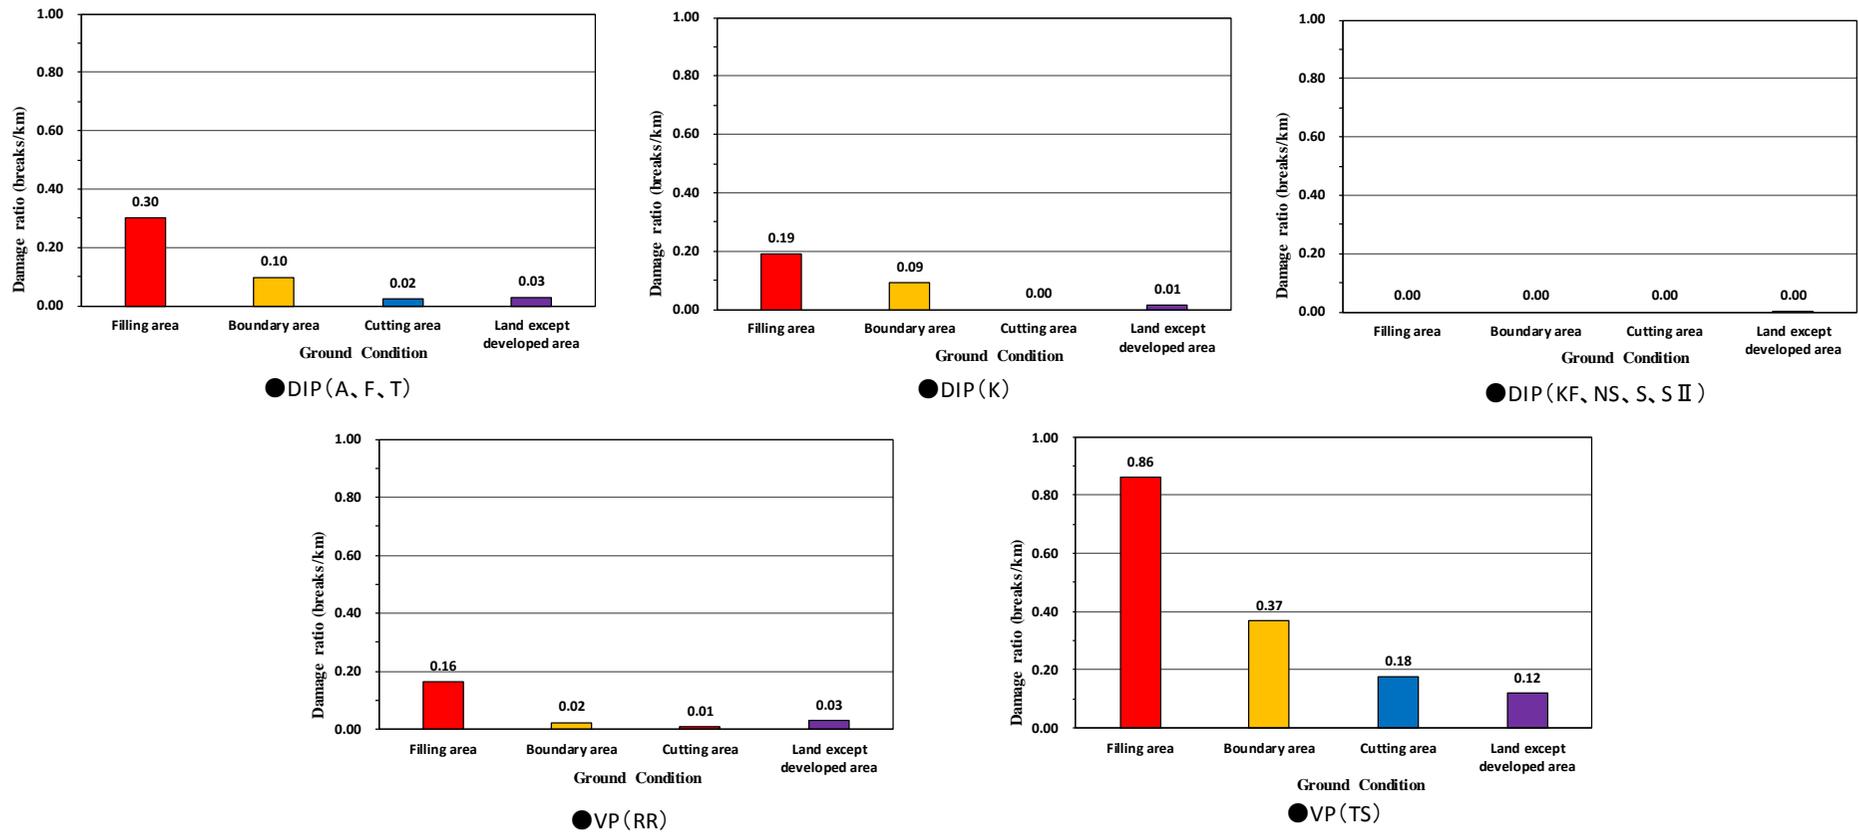
Figure 5 Damage ratio for pipelines per ground condition by pipe materials and joints.

Figure 5 shows the damage ratio for pipelines each subsurface ground condition to different pipe materials and joints. Most pipe materials and joints have a tendency that damage ratio becomes higher in order of cutting, boundary, and filling area. Damage ratio of DIP (A, F, T) and VP (TS) are higher than that of the others. As a result, it is suspected that these pipes don't have earthquake resistant performance like DIP (KF, NS, S, S II) . In addition, the material of VP (TS) is less stronger than the others, so the damage ratio of VP (TS) is the highest. Therefore, it implies that DIP (A, F, T) and VP (TS) installed in filling area have high priority to be replaced by earthquake resistant pipe.

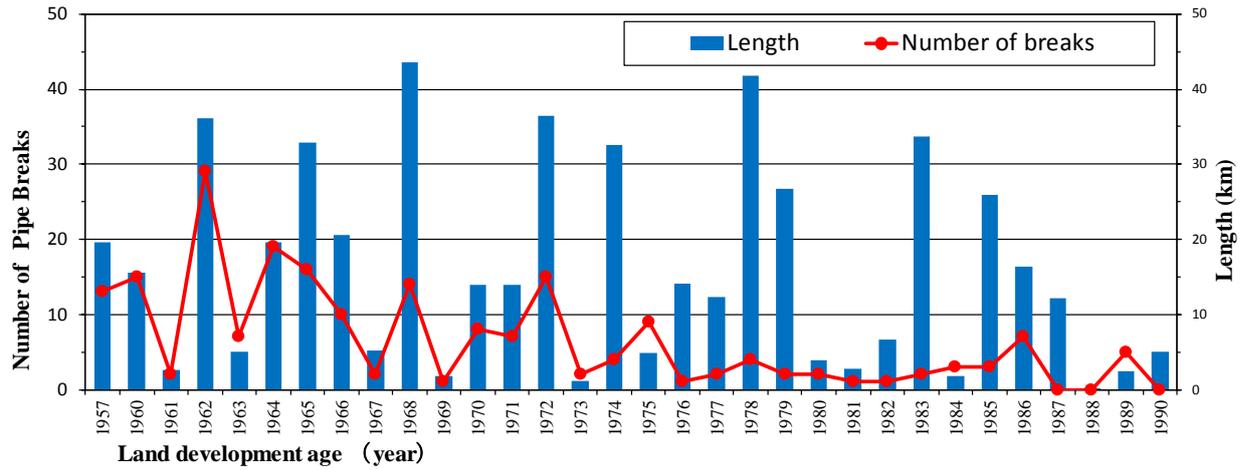
Figure 6 Number of Pipe Breaks and Length in filling area

Figure 6 shows number of pipe breaks and length of pipeline and Figure 7 shows the damage ratio in filling area according to land development age. The damage ratio in filling area is approximately 0.9 (breaks/km) before 1965, it is approximately 0.4 after 1965. Damaged water pipe installed in filling area was not found after 1990. It makes a clear tendency that pipes have lower damage ratio according to land development age. In 1965, Sendai city applied an Act on Regulation of Residential Land Development, the act decides technical standard for the construction. This suggests that strength of subsurface ground condition become higher after 1965, and also the figure shows there are few number of pipe breaks. Therefore, it is necessary to pay full attention to the pipes installed in filling area that developed for the past several years ago. Also, it implies that pipes installed in filling area have high priority to be replaced by earthquake resistant pipe.

• After 1990, damaged pipeline was not found in filling area.
