Welcome Address and
Keynote Lecture

Fault Crossing Pipeline

Masakatsu Miyajima
Professor of Kanazawa University,
Japan

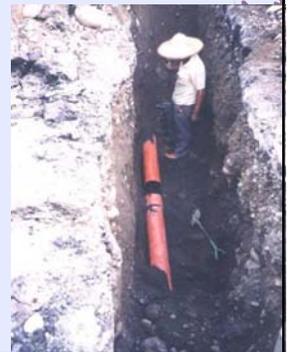
Damage to buried pipe by fault rupture

1999 Chi-Chi earthquake in Taiwan

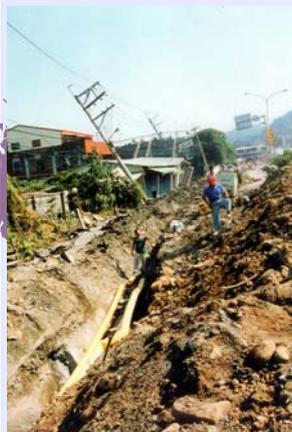
1999 Chi-Chi Earthquake in Taiwan

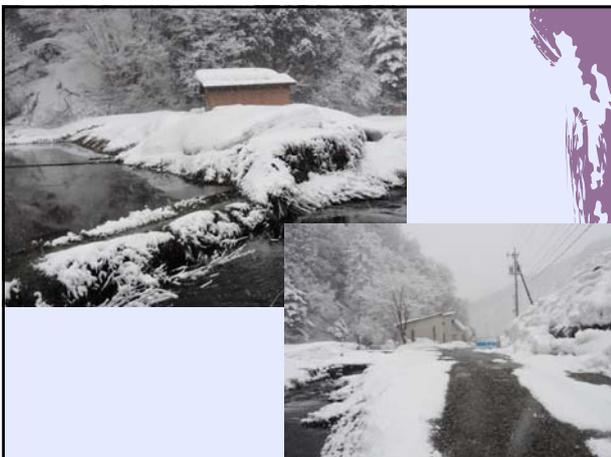
長野県神城断層地震 管路被害状況(白馬村)

②・③ 大出 断層変位(30cm) T形, PE φ100被害
